Northern Star Marine Ltd
NARROWBOAT SURVEYS
& Boat Safety Scheme Certification

....Survey Report....

That I the undersigned carried out a pre-purchase condition survey on the vessel below at the request of

Name:	Type:	Cruiser style Narrowboat
Hull Builder:	Springer	Fit-out:
Approx. Year of build:	1970's	Index:
CIN No:	Not applicable	Approx. Length:	36ft
Approx. Draught:	2ft 3in

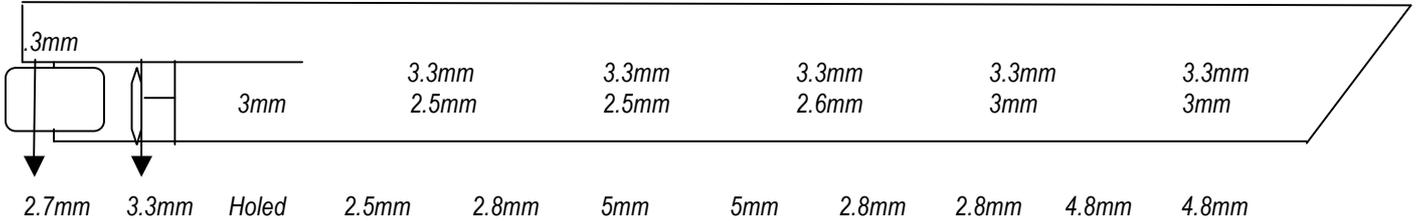
Starboard readings:

Ultrasonic measurements were taken with a Tritex 5500 triple echo meter with a 13mm probe. The side plates had a covering of marine growth and were not pressure washed prior to inspection. Approximately thirty sample areas were selected at random and prepared for inspection. From the sample areas selected, ultrasonic measurements show the plate thickness to be between 2.5mm and 3.3mm, which are not within acceptable limits. Two small sections of the aft transom have been patch overplated to a poor standard.

From the sample areas selected, ultrasonic measurements show the plate thickness to be between 0mm and 5mm, which are not within acceptable limits. The bottom plate was holed below the engine.

Rec 1: *Overplate the sides with 4mm or 5mm steel plate up to the lower rubbing strakes.
Replace the two small sections of patched overplating on the aft transom.*

Rec 1: *Overplate the bottom with 4mm or 5mm steel plate.*
