Northern Star Marine Ltd
NARROWBOAT SURVEYS
& Boat Safety Scheme Certification

....Survey Report....

Name:	Type:	Traditional style narrowboat
Hull Builder:	Approx. Year of build:	1998
Index:	Approx. Length:	58ft
Approx. Draught:	2ft

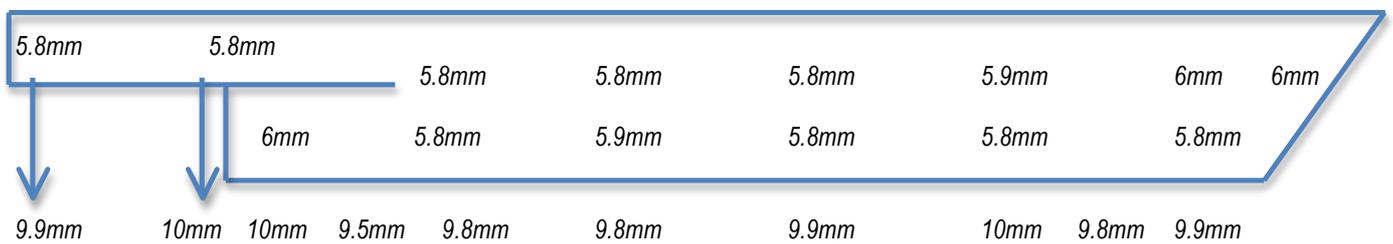
Starboard side readings:

Ultrasonic measurements were taken with a Tritex 5500 triple echo meter with a 13mm probe. The side plates had a covering of marine growth and were not pressure washed prior to inspection. Approximately thirty sample areas were selected at random and prepared for inspection. From the sample areas selected, ultrasonic measurements show the plate thickness to be between 5.8mm and 6mm, which are within acceptable limits.

Widespread pitting corrosion is present which is minimised around the anodes. The maximum pit depth measured was approx. 2mm, and the average pit depth was approx. 1.7mm with approx. 75% coverage, which is only just within acceptable limits. The areas around the forward and aft anodes are pitted to a lesser degree and the average pit depth measured at these points was approx. 1mm. The vessel will require remedial attention in the future if the pitting develops any further.

Rec 4: *I recommend shot-blasting the hull and applying a 2-pack epoxy coating, then fitting 2 x additional anodes on both the port and starboard sides, to help minimise any further pitting corrosion. It would also be prudent to install a galvanic isolator (I recommend that the above be carried out straight away)*
